NIST NCSTAR 1-5A

Federal Building and Fire Safety Investigation of the World Trade Center Disaster

Visual Evidence, Damage Estimates, And Timeline Analysis

(Chapter 9 - Appendix C)

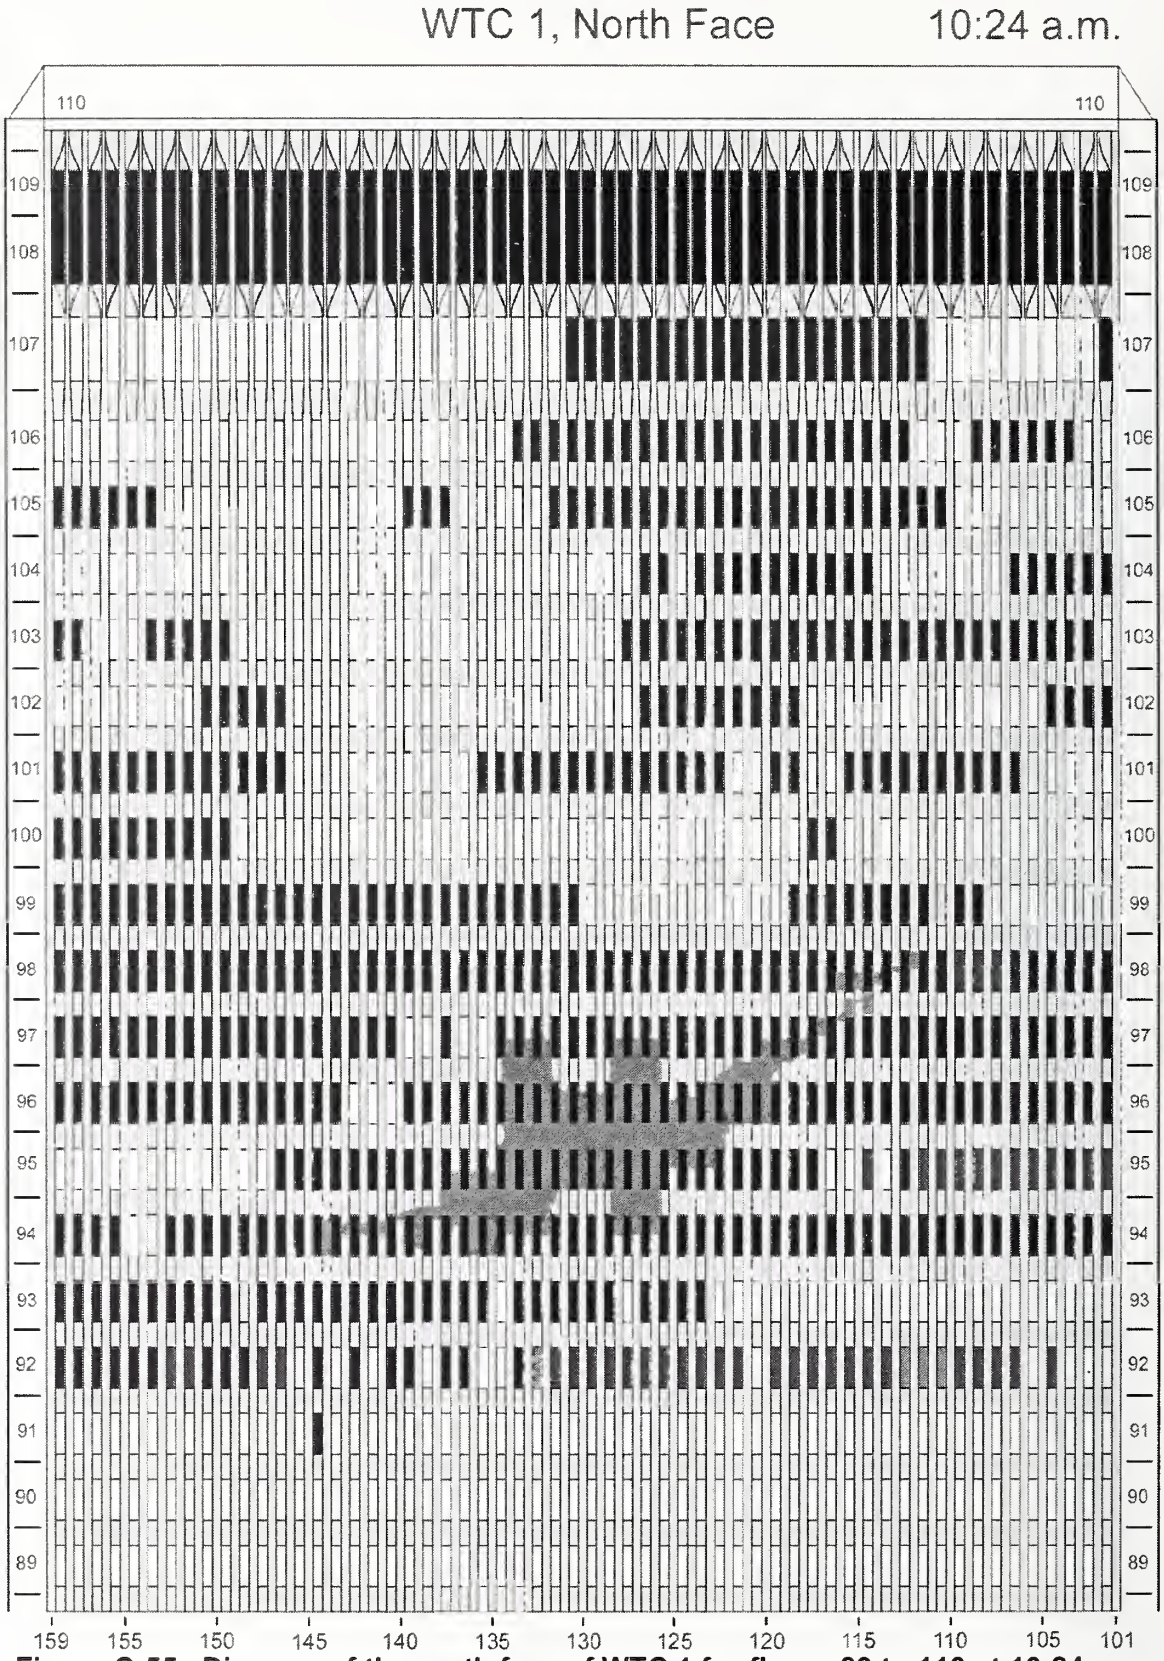
Figure C-55. Diagram of the north face of WTC 1 for floors 89 to 110 at 10:24 a.m. showing the condition of windows and locations of fires.

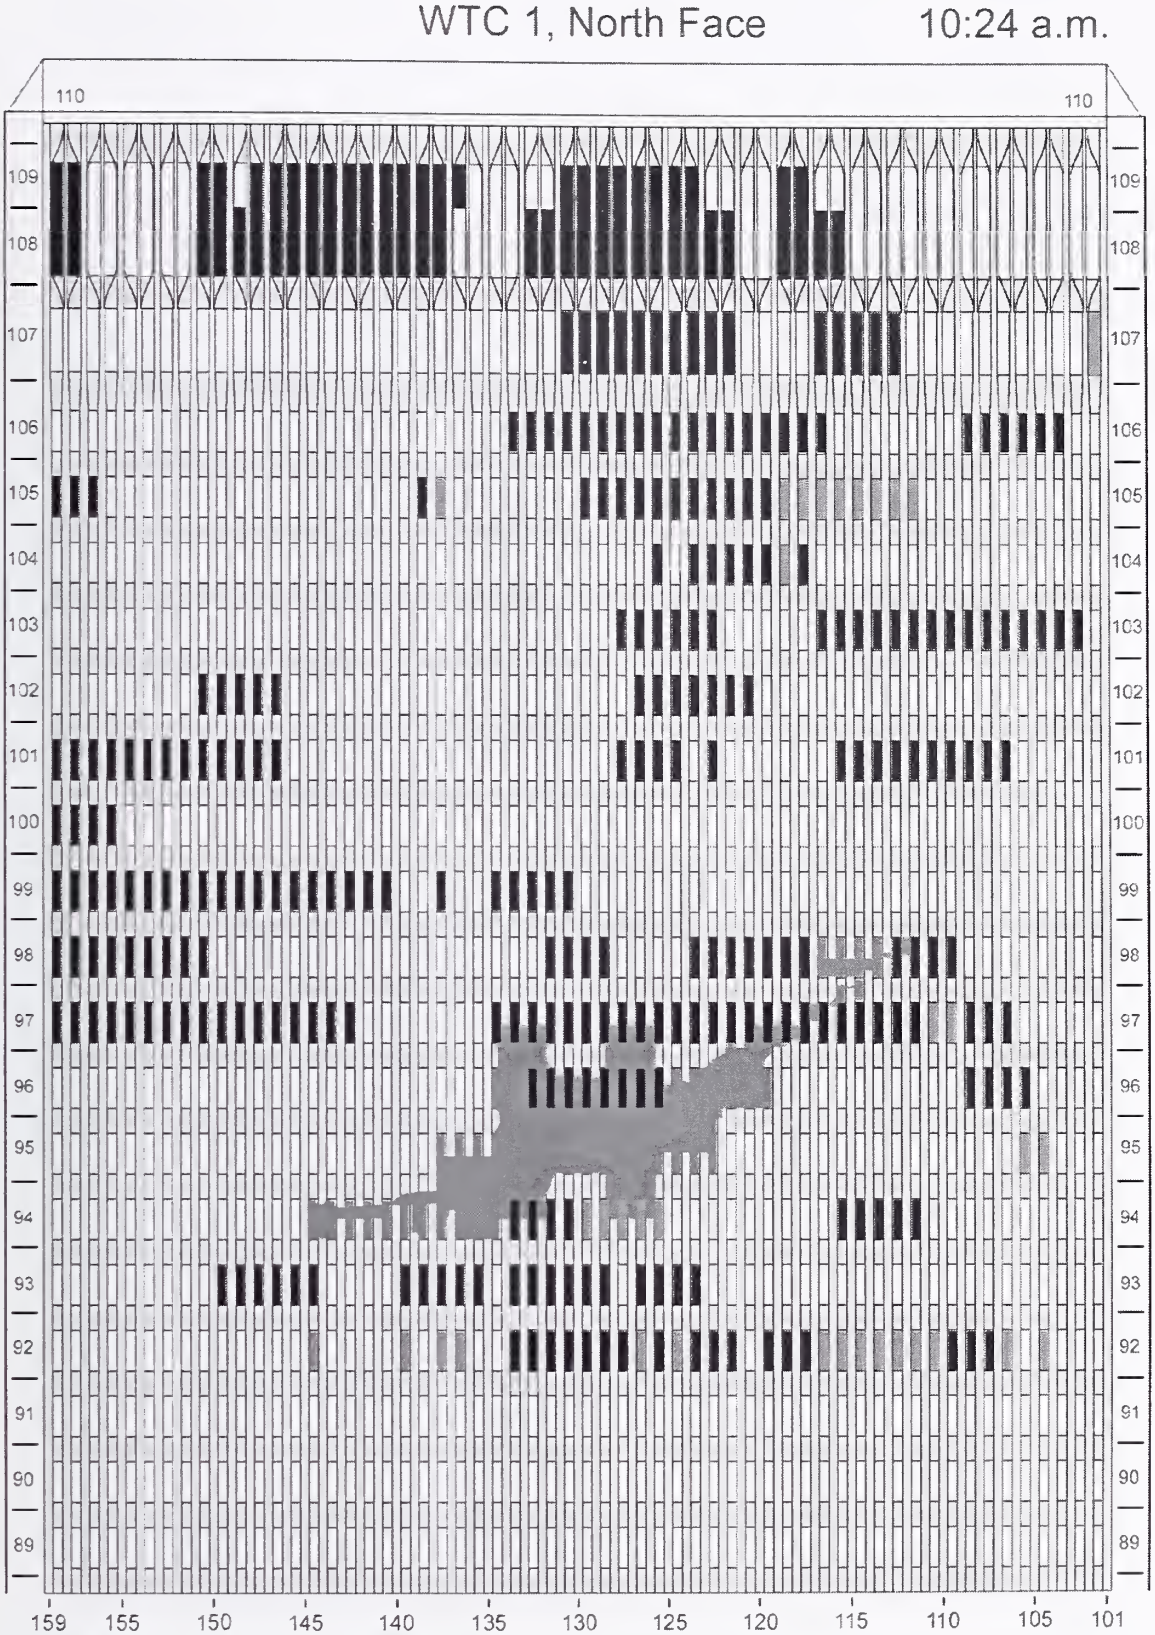
Figure C-56. Diagram of the north face of WTC 1 for floors 89 to 110 at 10:24 a.m. showing windows where smoke was observed and those that were hidden from view.

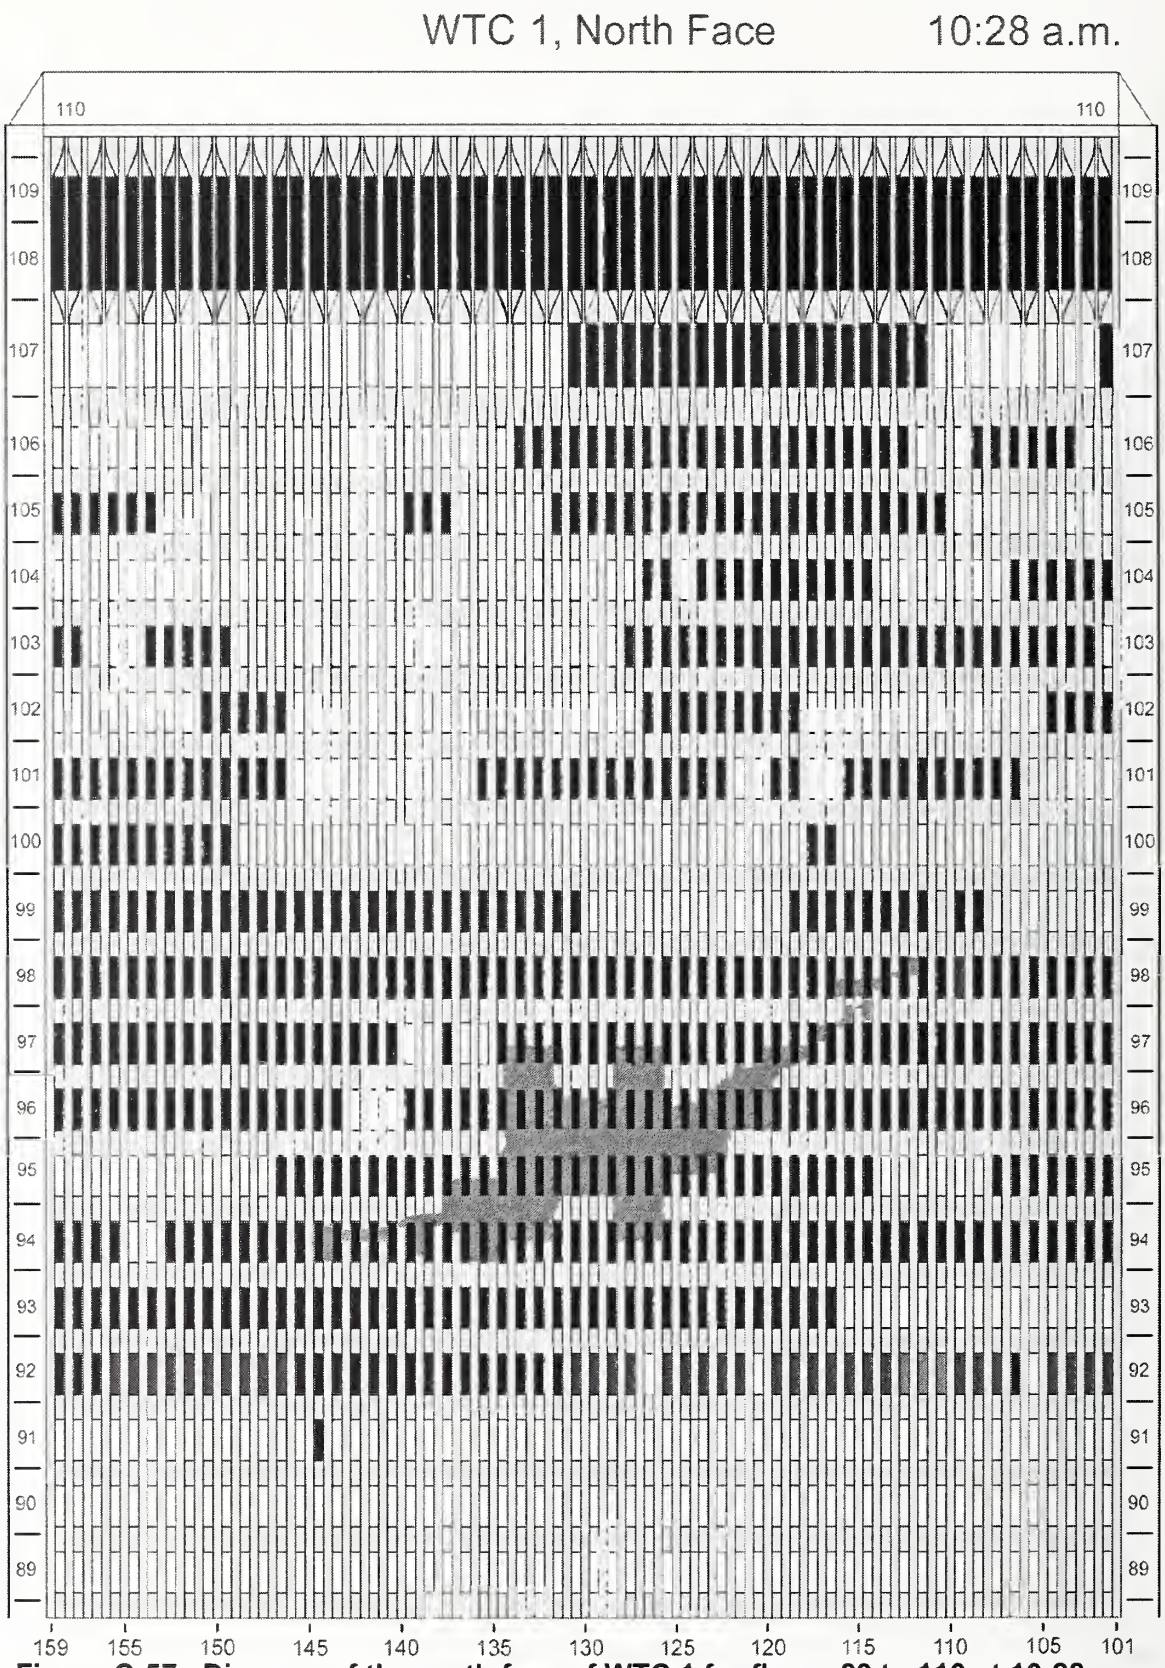
Figure C-57. Diagram of the north face of WTC 1 for floors 89 to 110 at 10:28 a.m. showing the condition of windows and locations of fires.

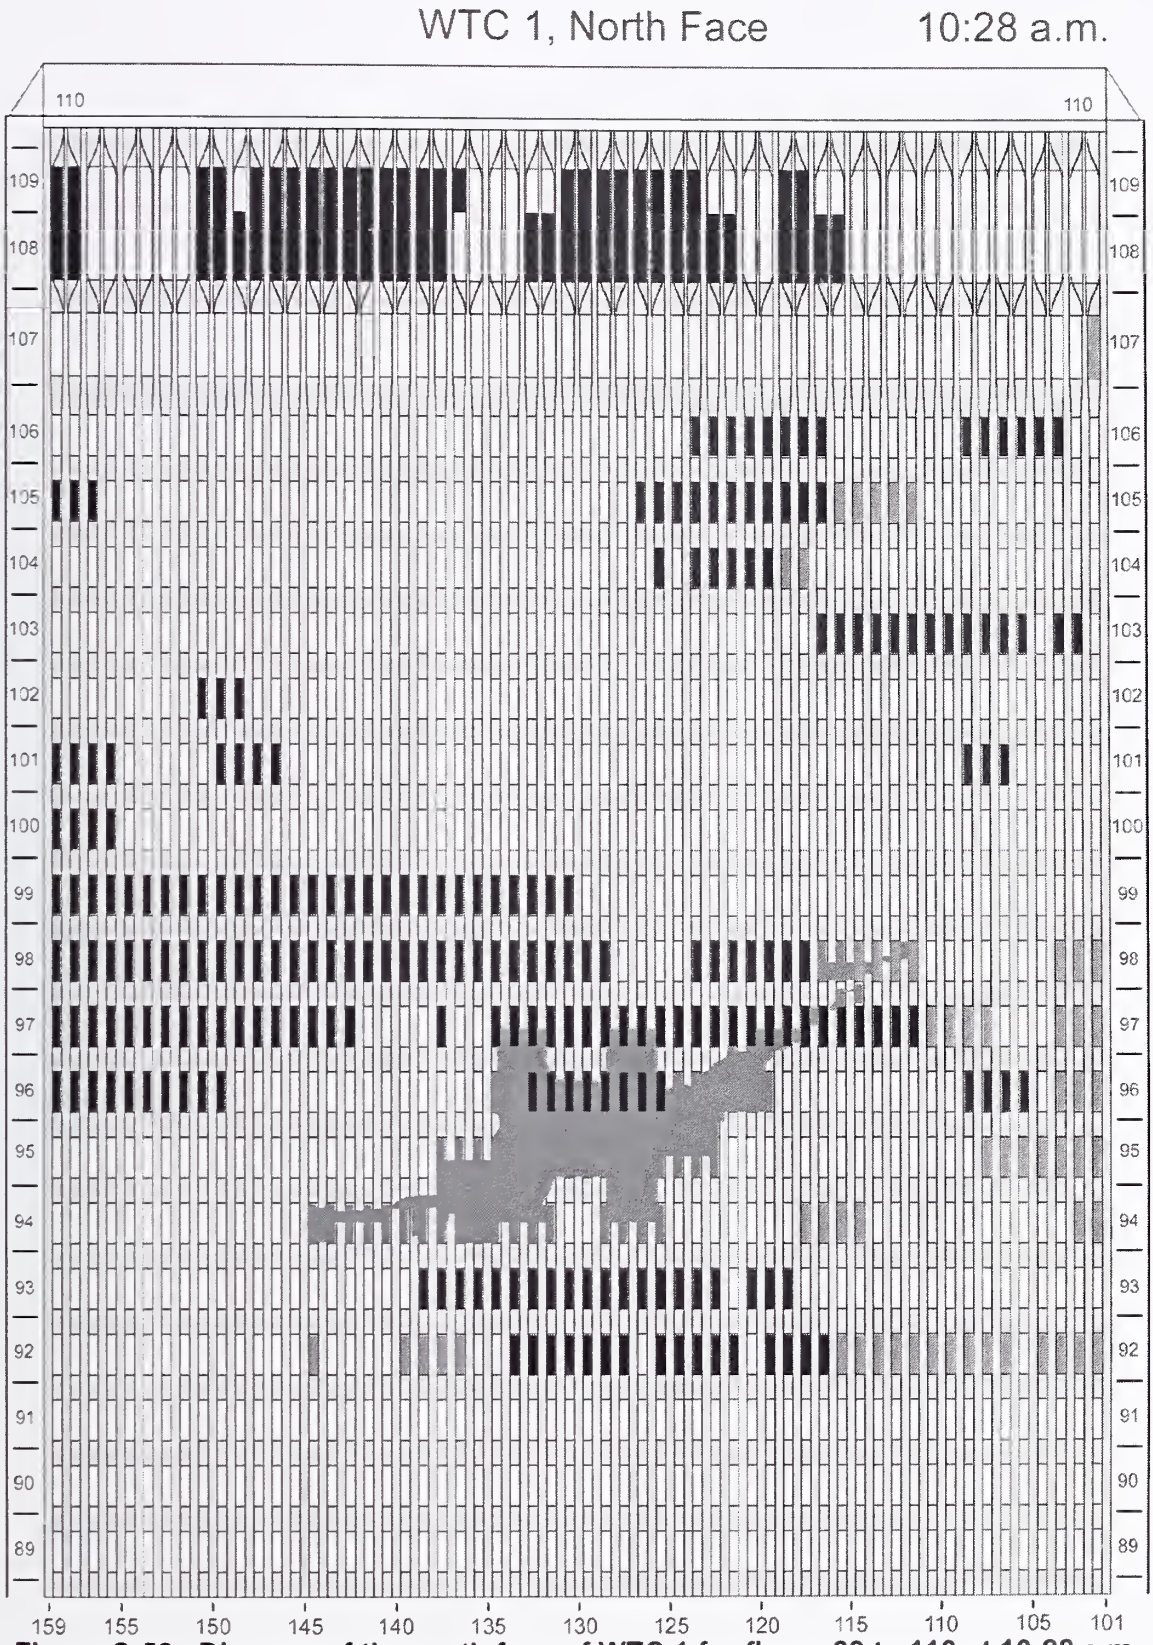
Figure C-58. Diagram of the north face of WTC 1 for floors 89 to 110 at 10:28 a.m. showing windows where smoke was observed and those that were hidden from view.
